Pro Team Inspections

Inspection Report

Property Address:
12839 Quailbrook Drive
Jacksonville, Florida

Date: 8/15/2007

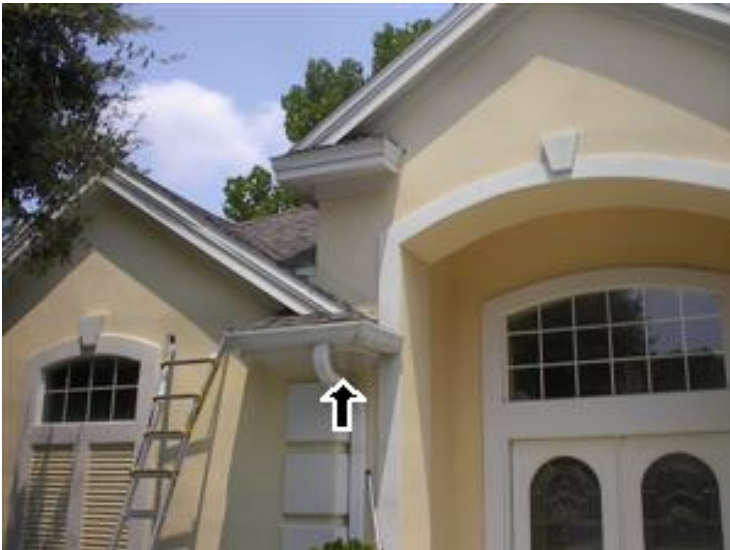
2.0 Picture 1

The wood soffit/fascia has wood deterioration left of the front entrance. (picture-1)

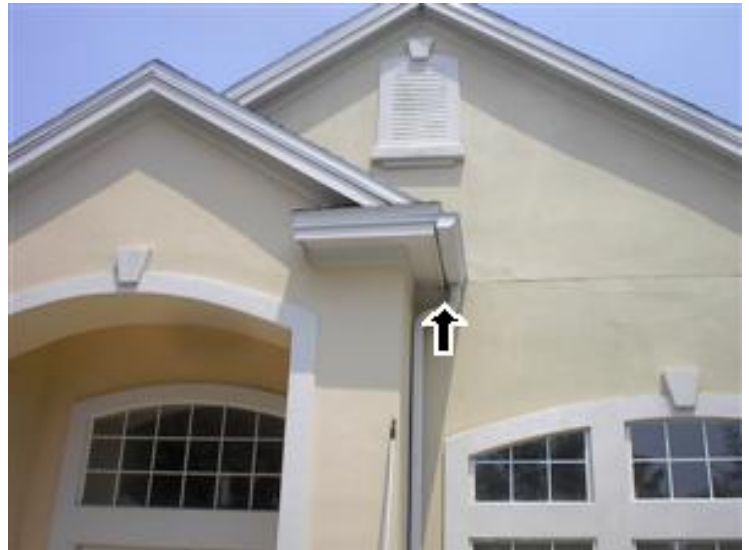
2.0 Picture 2

The wood soffit right of the front entrance has wood deterioration. (picture-2)

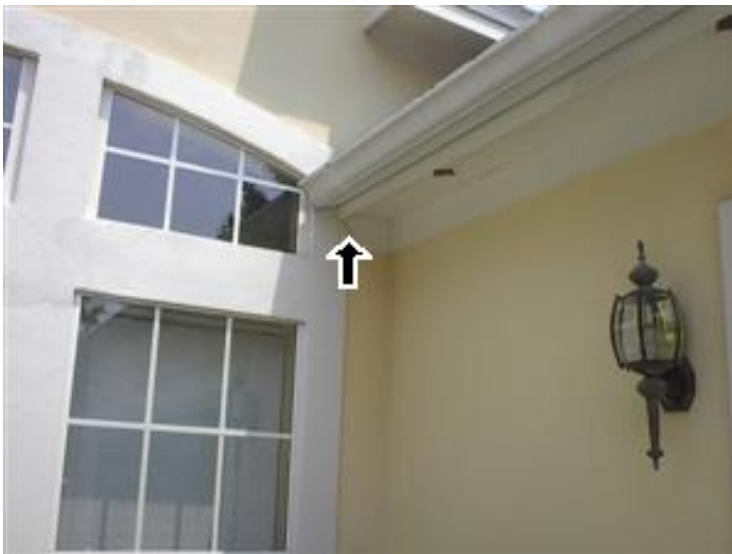
2.0 Picture 3

The wood fascia right of the dining room window (under gutters) has wood deterioration. (picture-3)

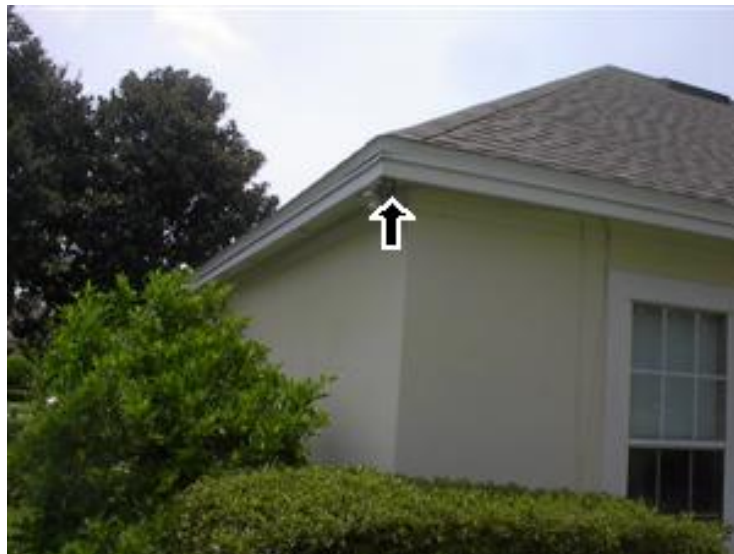
2.0 Picture 4

The wood fascia has minor wood deterioration at the left rear corner (facing front). (picture-4)

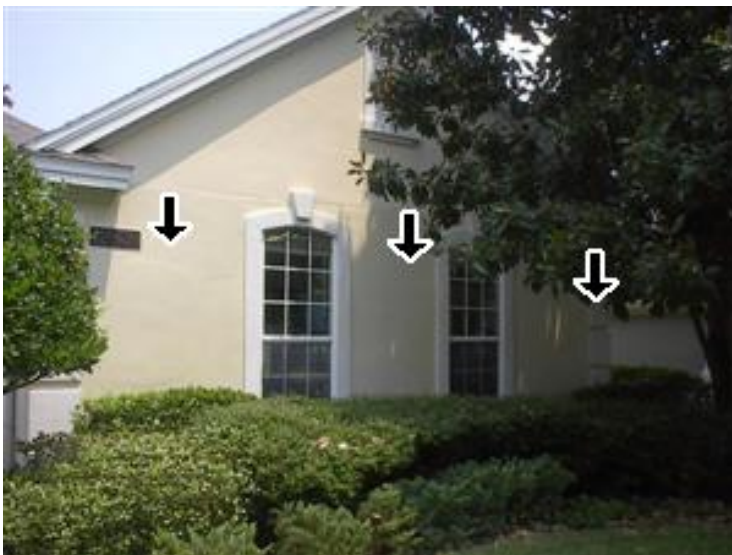
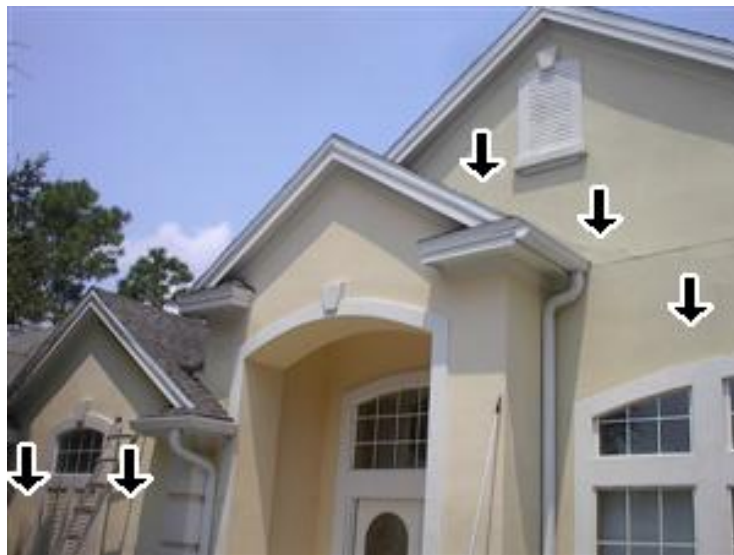
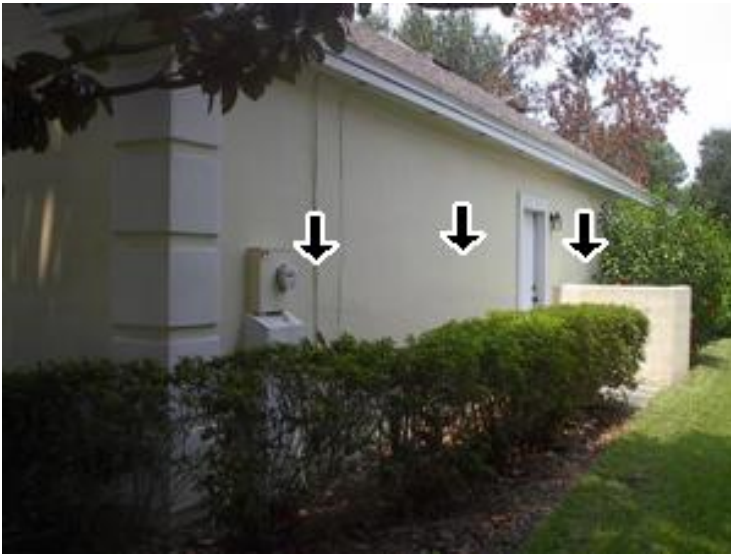
The exterior wall cladding and window bands were found to be in fair condition overall. Repairs are visible at all elevations of the home. The repairs appear to be stable and structurally sound. The repairs as completed have visible joints (these are called cold joints) which can produce additional cosmetic cracking in the future. The stucco repairs do not appear to be completed in a manner which would have allowed all wall and window flashings to be corrected as part of the overall stucco repairs. (pictures 1 thru 3 are typical areas of repairs)

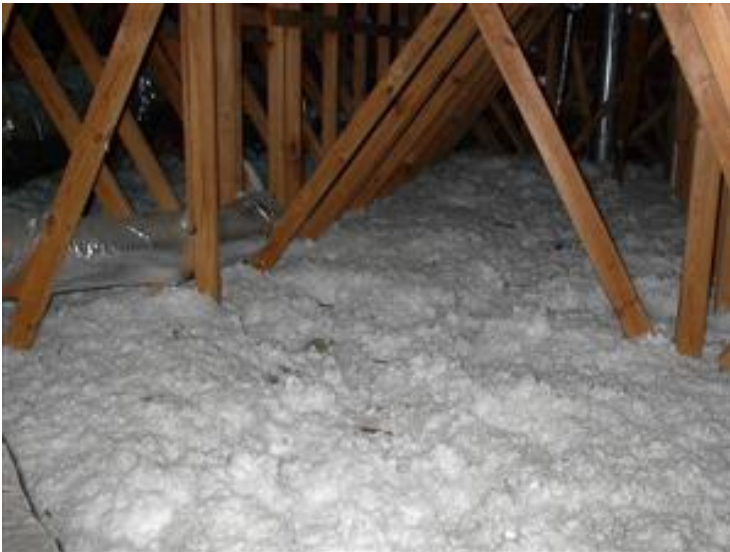
6.1 Picture 1

Fiberglass (loose-fill) insulation is about ten inches thick or just over 31 R-value.

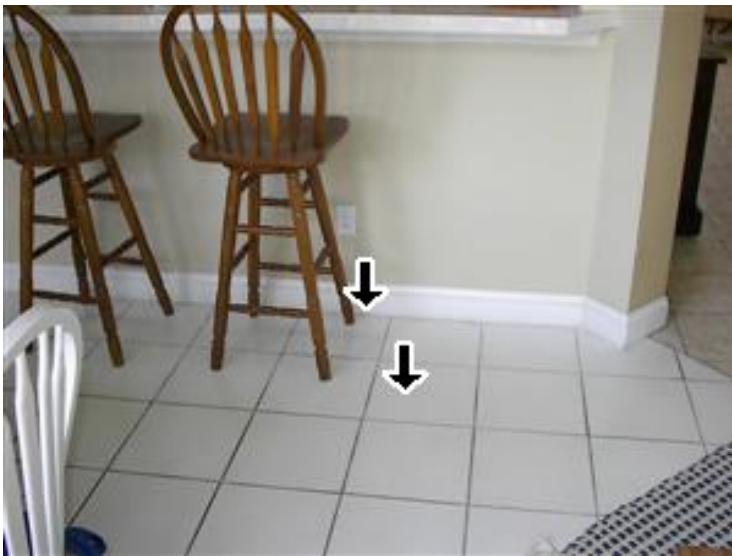
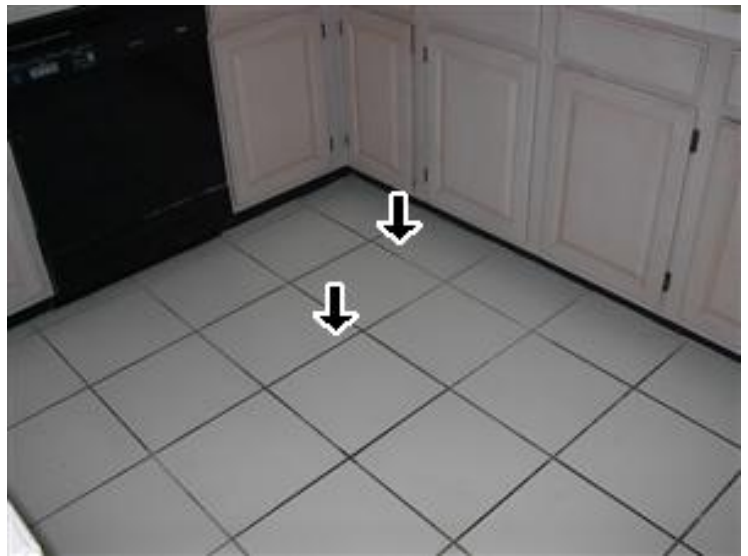
Several of the floor tiles in kitchen area are cracked (Pictures typical). The tiles are stable and cracks appear to be cosmetic concern only.

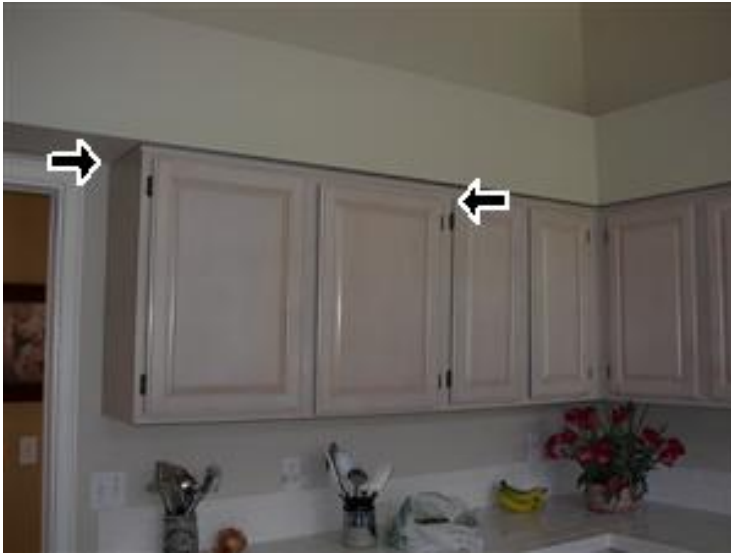
8.10 Picture 1

The upper cabinets on wall across from kitchen sink are loose at top (Picture 1). Advise to review and repair or secure as needed.

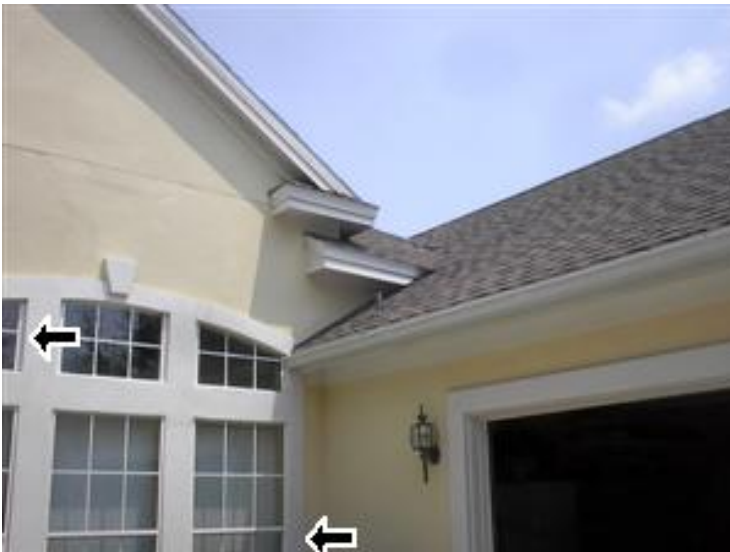
9.3 Picture 1

Two of the dinning room windows are fogged. The top left arch and the bottom right single hung (Picture 1).

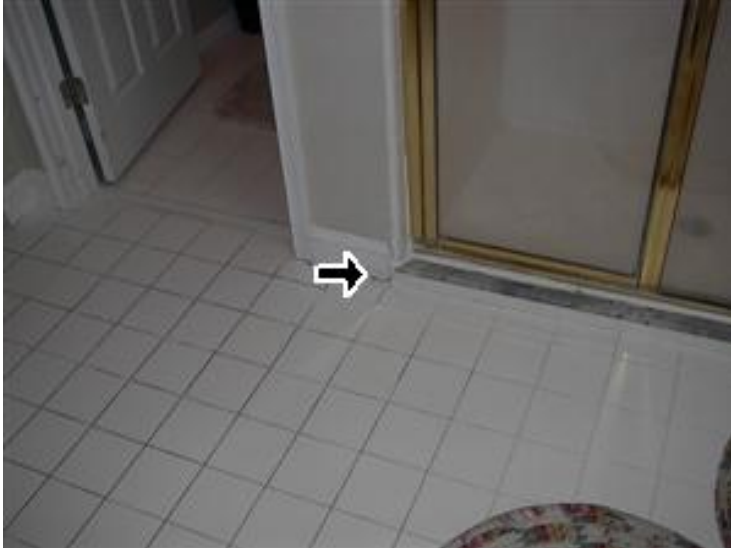
11.0 Picture 1

The base board left of shower door at master bath has moisture damage (Picture 1). Advise to maintain caulk/seal at tile surround.

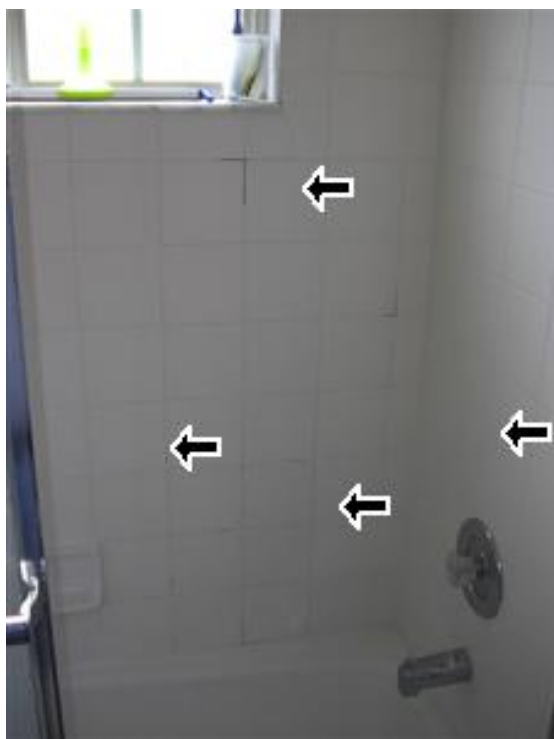
12.0 Picture 1

The tile surround at the shower of the hall bathroom (Picture 1 typical) and master bathroom (Picture 2 typical) were found to have loose tiles at the rear walls. The tile surround substrates were tested with a moisture meter and were found to have a high moisture content. This indicates moisture has penetrated through cracks in the tile grout to the wall substrate. The master bath shower floor has several cracked tiles (Picture 3). Advise review and repair as needed by a licensed tile contractor.

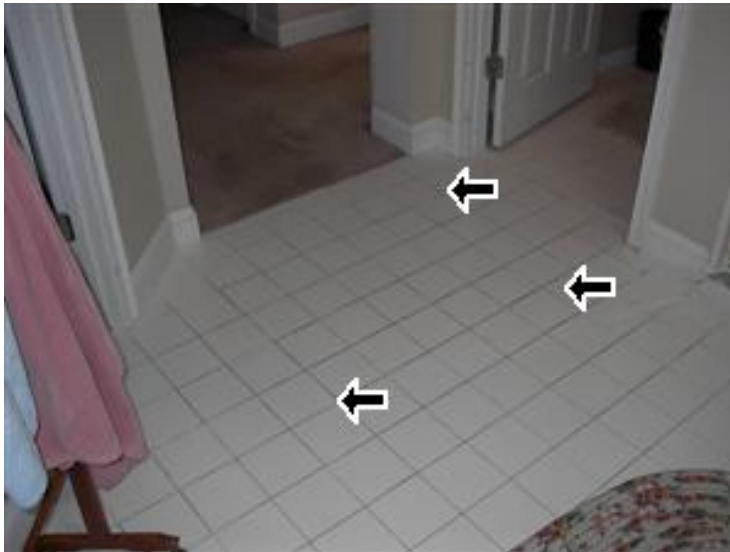
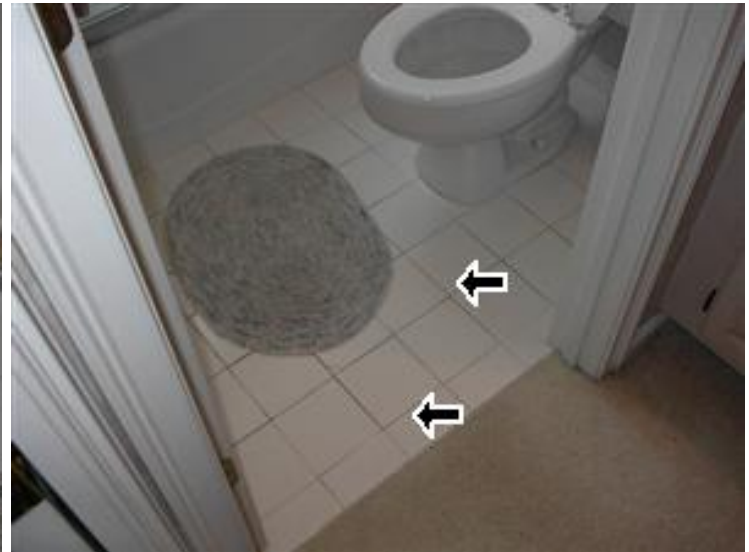
Both bathrooms tile flooring have several cracked tiles (Pictures typical). Advise review and repair as needed.

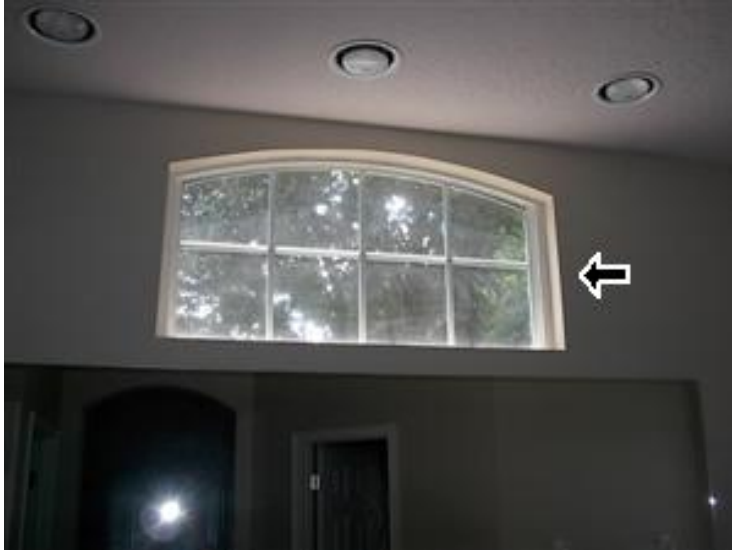
12.5 Picture 1

The arch window in master bath is fogged (Picture 1).

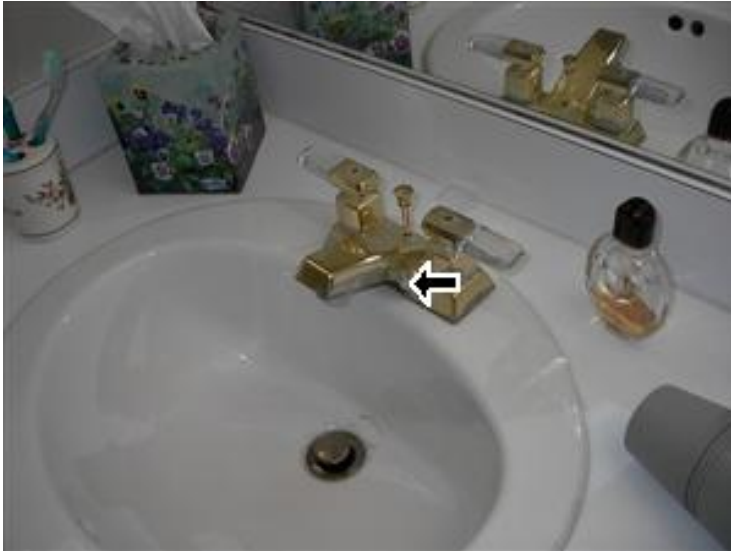
13.1 Picture 1

The finish on all master bath fixtures is worn, but all fixtures were functional (Picture 1 typical).

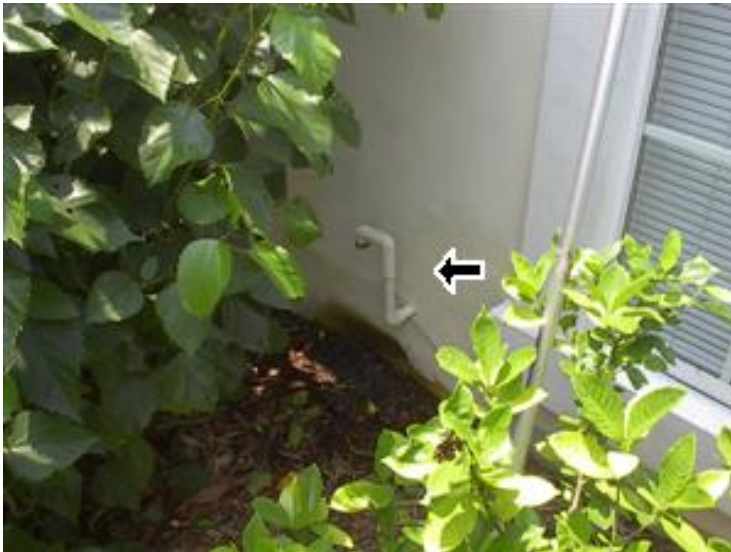
16.2 Picture 1

Exterior condensate line should be extended from home foundation approximately 2-3 feet.

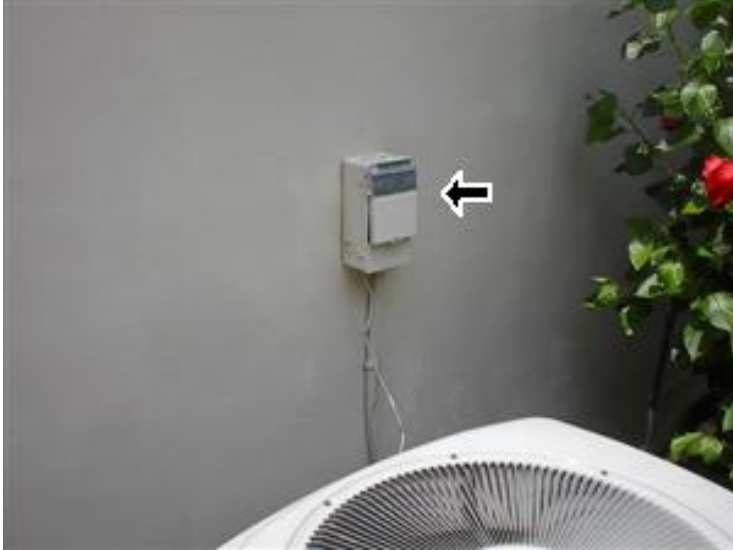
16.6 Picture 1

The electrical disconnect door is loose and will require repairs.
