Property and Site

Sunny Cloudy Rain Wet
Approx. Temperature 62 Year House Built 1967

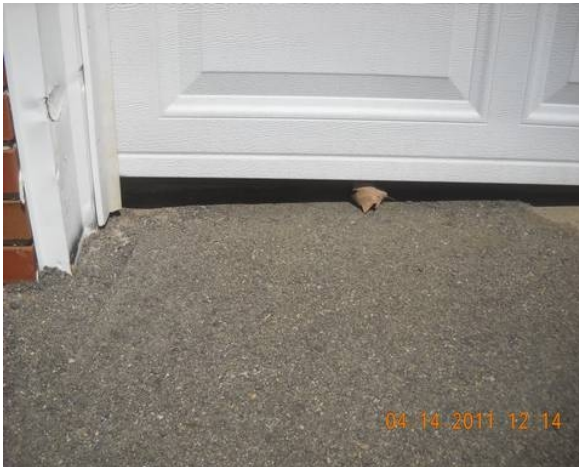
1.1 Driveway

Driveway has sunk and is leaving a gap between the garage door and the driveway. This problem extends into the garage floor. This entire section should be removed and replaced.

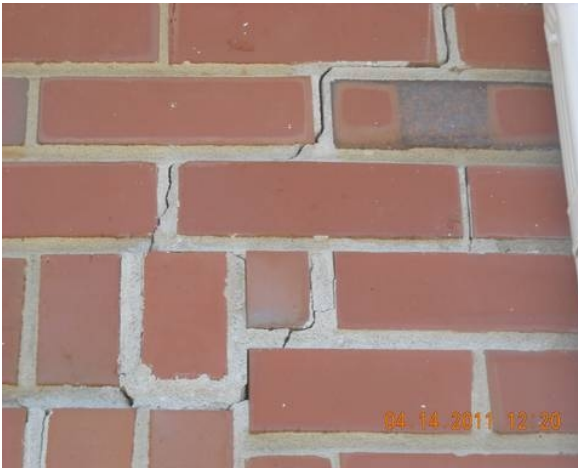
Small brick and mortar cracks noted on the upper right hand corner of the garage door. Though they do not appear to be of major structural concern, the gaps should be sealed to prevent moisture from getting behind the wall surface.

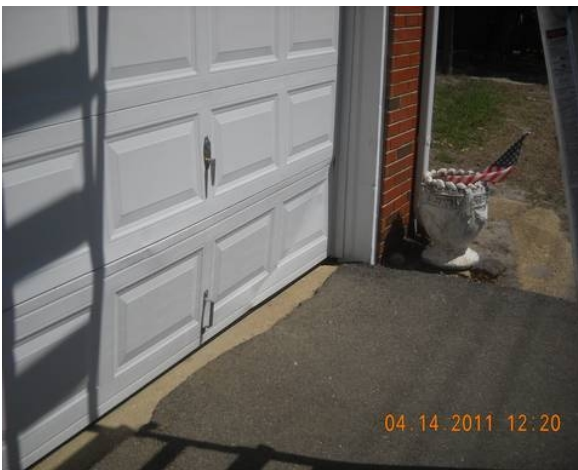
3.1 Door

Bottom two panels are bent and the bottom panel is also broken. Replace.

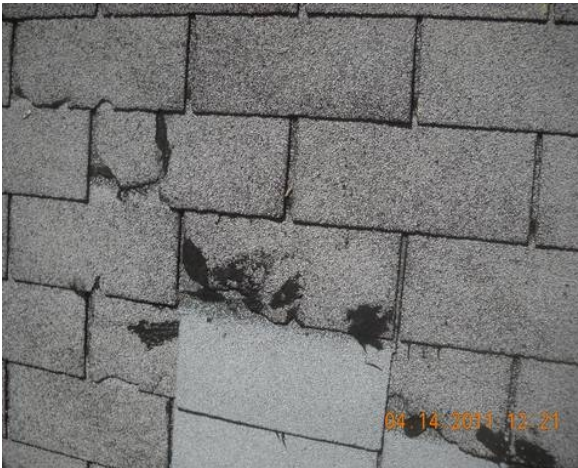
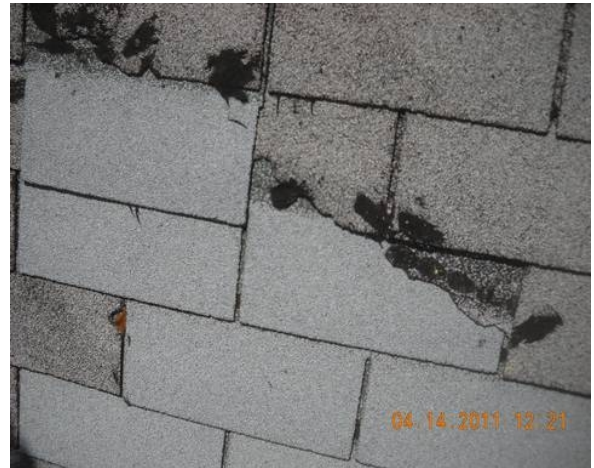
Improper overhang, should be max 3/4 - 1 inch, correct to prevent shingles breaking off and water intruding causing damage.

Improper repairs noted. There are broken shingles on the roof where only the damaged part has been replaced. When a part of the shingle is broken the entire shingle should be replaced. Have a qualified roofing contractor correct.

Have a qualified roofing contractor replace all damaged shingles.

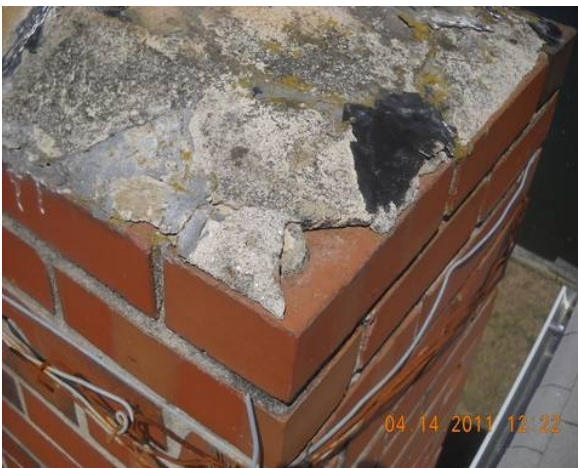
4.3 Chimney Cap

Masonry crown is cracked and the mortar is receding. Have a qualified chimney sweep coat masonry crown to eliminate potential structural problems.

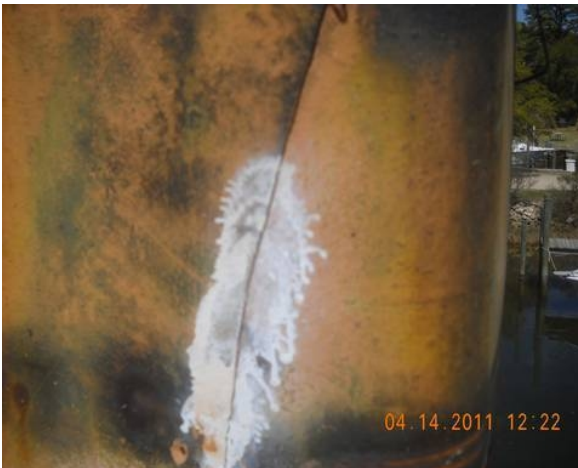
4.4 Visible Flue Liner

Cracks noted in the clay liner for the fireplace. Consult a certified chimney sweep to further inspect clay liner for additional cracks, visible portion shows spalling and cracks. May extend to concealed areas within chimney assembly.

Replace all damaged sections. **This is the reason that the flue has been blocked off.

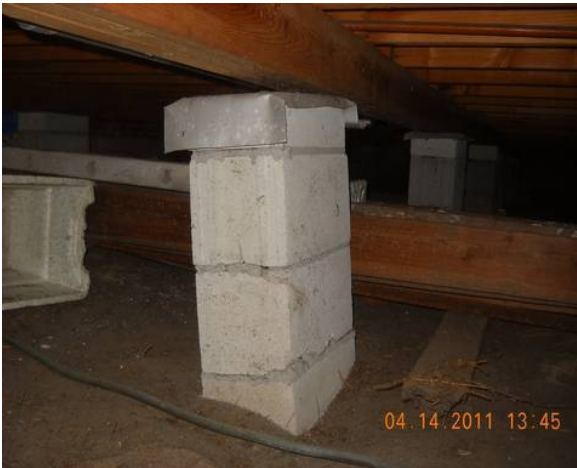
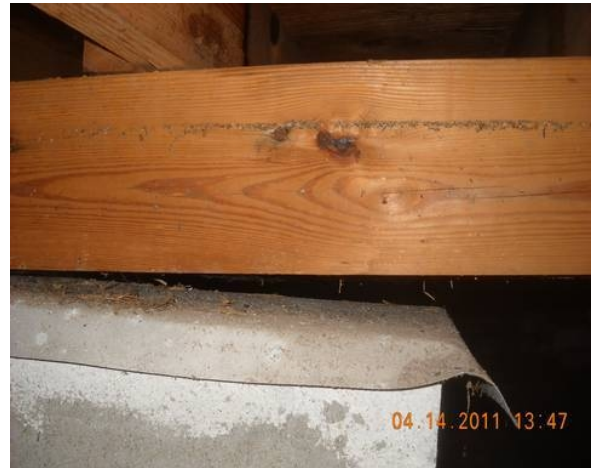
The center row of interior piers are settling and some are leaning and others are not touching the beams that they are intended to support. Have a qualified contractor support beam and replace the settling footers and then re-lay the piers.

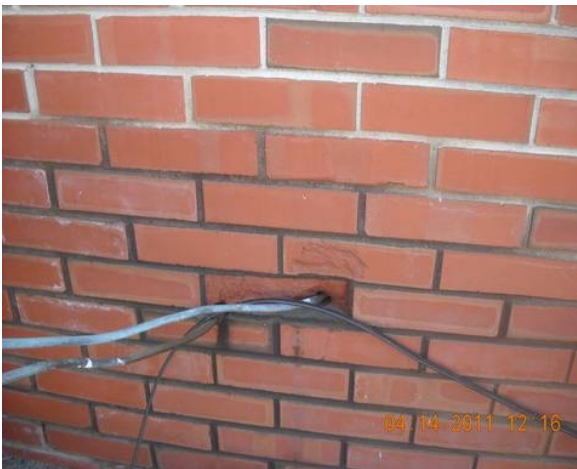
7.1 Oil Tank/Piping

There appears to be a leak in the oil tank piping where it passes through the bricks into the crawlspace (note stain on mortar). Have a qualified HVAC contractor evaluate and correct any and all leaks.
