Wood Destroying Insect Inspection Report

Address of Property Inspected
623 Camelot
Liberty, Mo. 64068

Attachments TERMINIX INSPECTION GRAPH

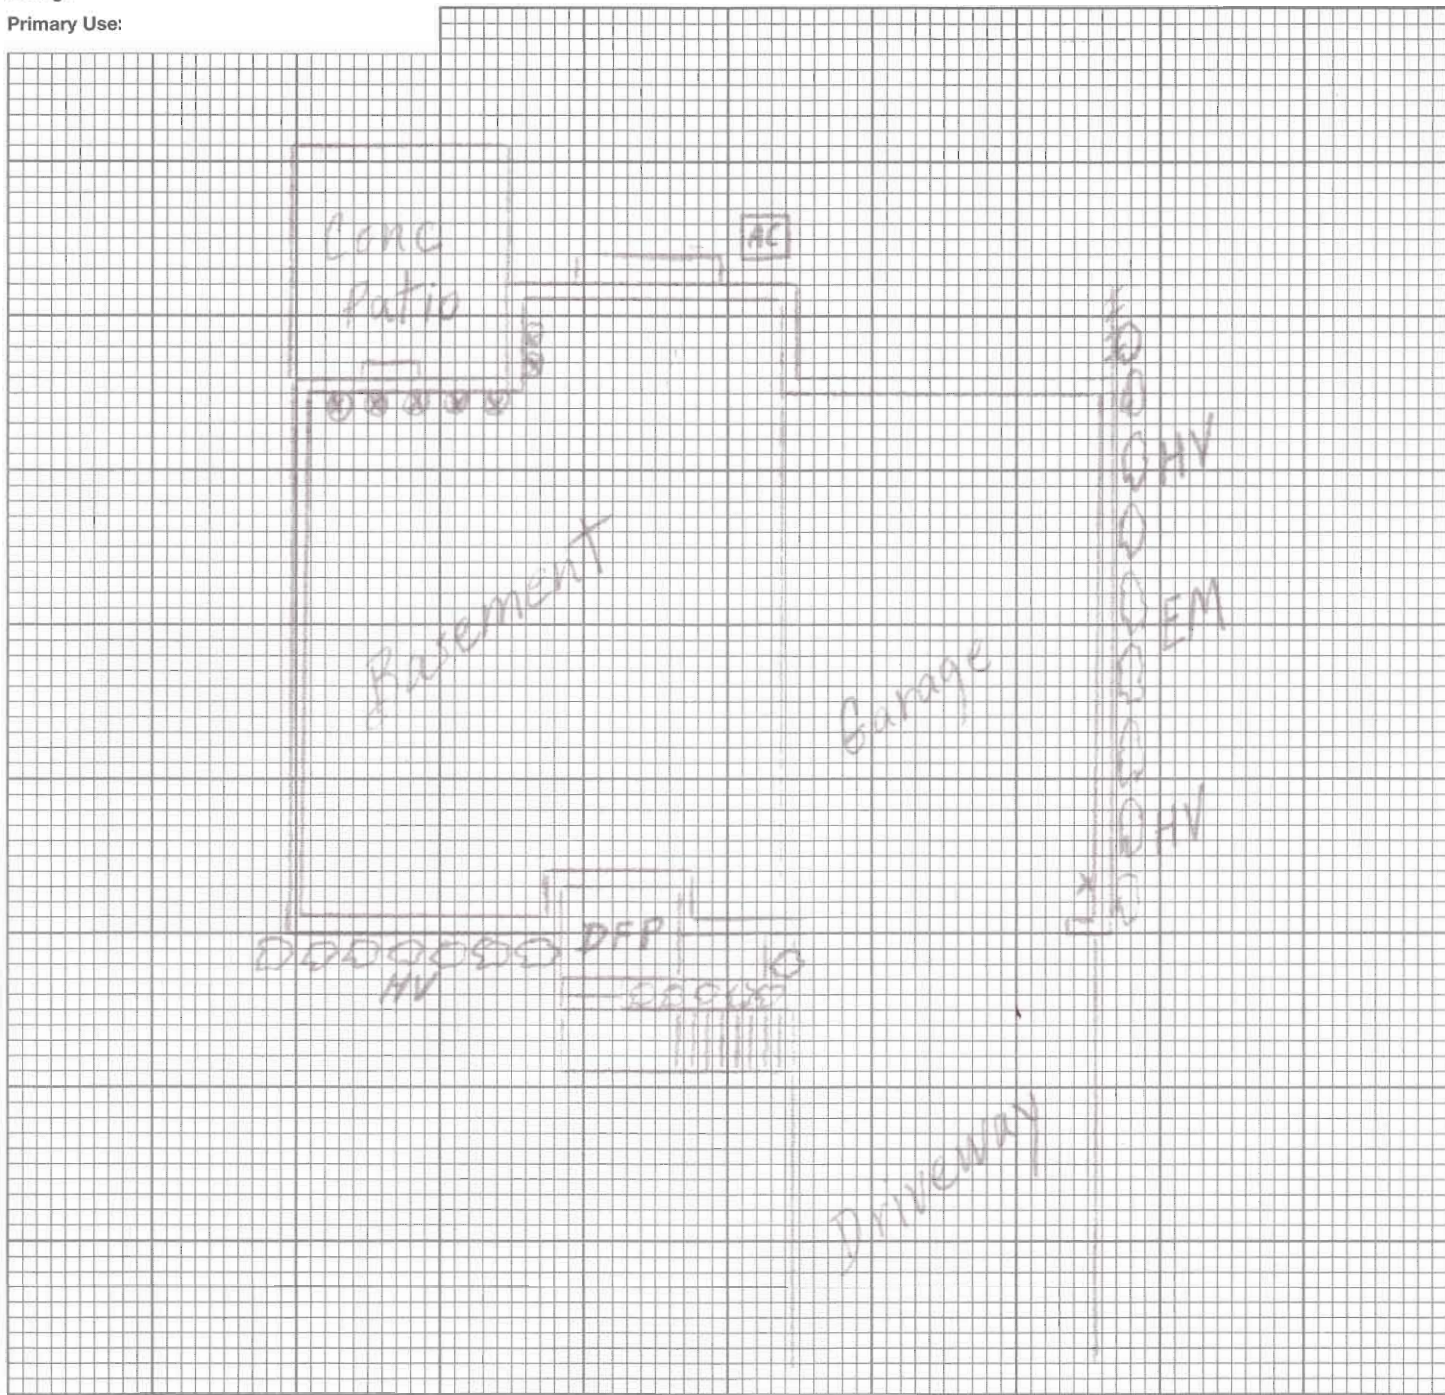
3. Visible damage from wood destroying insects was noted as follows (description and location): Subterranean Termite damage above back door and window next to back door inside home continuing around corner up high. Old damage, not recent

<input type="checkbox"/> PREVENTIVE TREATMENT OR <input checked="" type="checkbox"/> CONTROL TREATMENT	KEY TO EVIDENCE OF:	<input checked="" type="checkbox"/> SUBTERRANEAN TERMITES = X <input type="checkbox"/> DRYWOOD TERMITES = K <input type="checkbox"/> DAMPWOOD TERMITES = Z <input checked="" type="checkbox"/> EXISTING DAMAGE = ⊗ <input type="checkbox"/> FORMOSAN TERMITES = C	<input type="checkbox"/> POWDER-POST BEETLES = PPB <input type="checkbox"/> WOOD BORING BEETLES = WB <input type="checkbox"/> FUNGUS = F <input type="checkbox"/> WELL/CISTERN = W/C <input type="checkbox"/> POSSIBLE HIDDEN DAMAGE = PHD	<input type="checkbox"/> CARPENTER ANTS = CA <input type="checkbox"/> CELLULOSE DEBRIS = CD <input checked="" type="checkbox"/> EXCESSIVE MOISTURE = EM <input type="checkbox"/> FAULTY GRADE = FG <input type="checkbox"/> EARTH-WOOD CONTACTS = EC <input type="checkbox"/> INACCESSIBLE AREAS = IA

TYPE OF CONSTRUCTION: <input type="checkbox"/> CRAWL SPACE <input checked="" type="checkbox"/> BASEMENT	<input type="checkbox"/> MONOLITHIC SLAB	<input type="checkbox"/> FLOATING SLAB	<input type="checkbox"/> SUPPORTED SLAB

Recommended treatment for the control of: Upon seeing visible subterranean termite damage a liquid defend system is recommended since it has been 20 yrs since last treatment
